Operational and Maintenance Performance Assessment of Arizona Public Service (APS)

Final Report

January 14, 2005

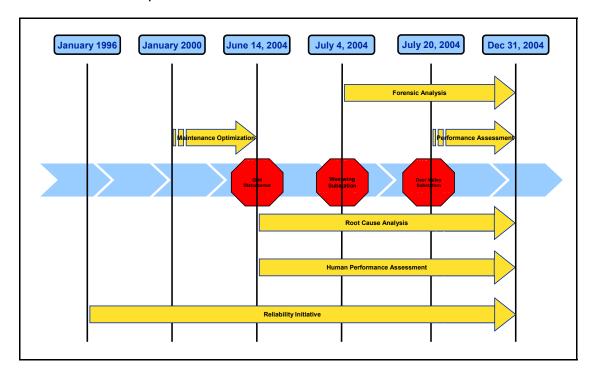
Figure 4
Sequence of Events, Actions and Response

In support of the analysis, EPRIsolutions staff and representatives of APS and HM&A developed a time line (Figure 4) to document the sequence of events (June 14, 2004, Grid Disturbance and subsequent equipment failures at the Westwing (July 4th, 2004) and Deer Valley (July 20th, 2004) substations) as well as to place each event as well as the various actions and responses provided by APS's organization in perspective. In 1996, APS started a major initiative to improve the organizations system reliability and service effectiveness. In 2000, APS's leadership partnered with EPRIsolutions in an initiative to benchmark their achievements as well as to continue to improve the organization's maintenance practices, effectiveness, overall performance, and equipment reliability. In this assessment, EPRIsolutions assisted in the identification of the progress made in the previous four (4) years.

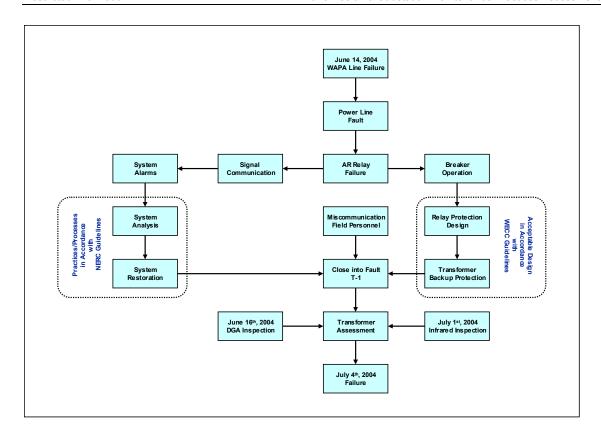
Figure 6 Sequence of Events

The analysis of the cause and effect during the June 14th, 2004, and July 4th, 2004, events showed that the primary cause for the damages to Westwing's T-1 transformer was the failure of the AR Relay as shown in Figure 6. As it relates to the sequence of events, the failure of the AR Relay caused the resulting breaker operation, communication of the signal and system alarms at the operations center. In response to the system alarms, the ECC operator analyzed the situation and implemented restoration procedures in accordance with NERC policies, guidelines and recommendations. A miscommunication between the field personnel and the ECC operator as well as the use of the AR Relays with primary and secondary signals linked to a single channel and the lack of backup protection systems on the transformers facilitated the breaker to be closed into the fault resulting in a deep, sustained fault to Westwing's T-1 transformer.

led to the eventual failure of the transformer on July 4th, 2004. The cause for the closure into the fault during restoration of service on June 14th, 2004, is attributed to a miscommunication (and contributed by the relay signal scheme and lack of transformer backup protection systems) between field personnel and the ECC operator. Policies and procedures used by the ECC operator adhered to NERC policies, procedures, guidelines and specifications. The analysis also shows that the failure of Deer Valley's transformer bushing was not related to the June 14th, 2004, event or the subsequent July 4th, 2004, Westwing event.
